**EVALUATING NONDESTRUCTIVE TESTING TECHNIQUES
TO DETECT VOIDS IN BONDED POST-TENSIONED DUCTS**

Final Report

**Florida Department of Transportation
(Contract No. BC 354-49)**

**M.E. Rinker, Sr. School of Building Construction
University of Florida
Gainesville, FL 32611**

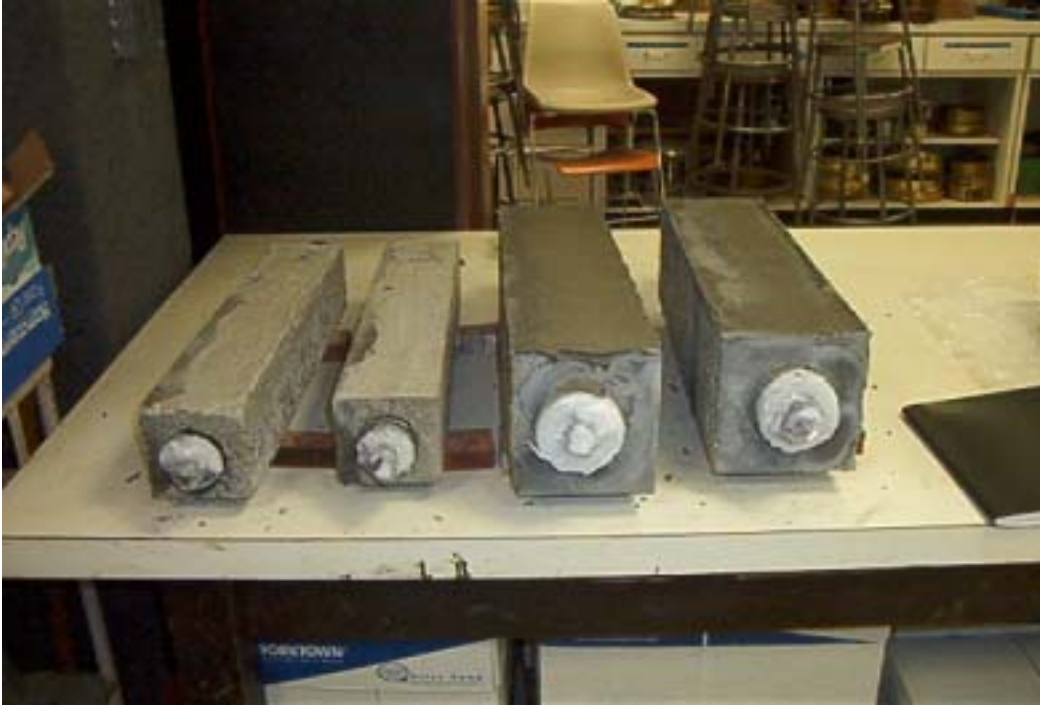
Figure 5.1 Grouted Beam Samples

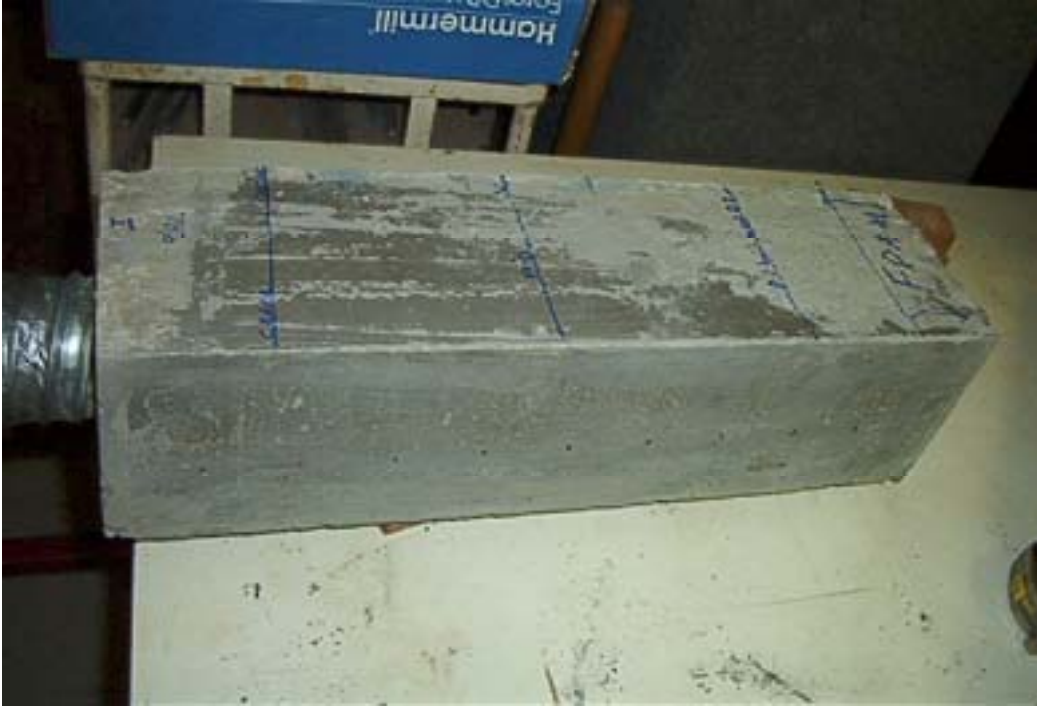
Figure 5.2 Grout Beam samples with Defect Locations

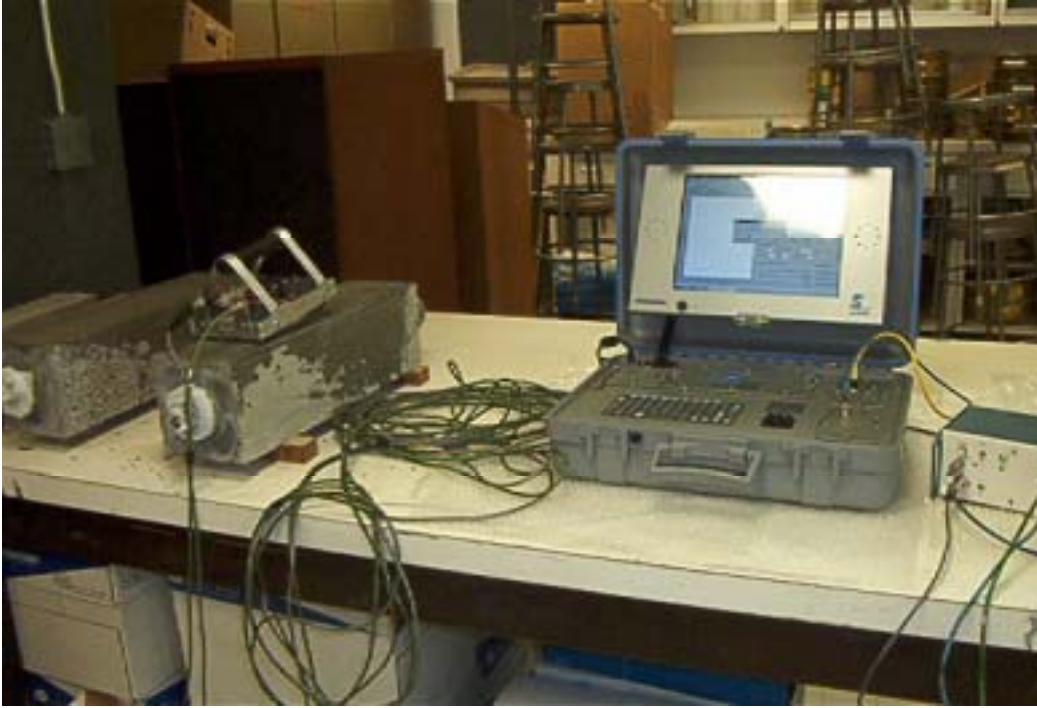
Figure 5.5 Scanning IE Device and Data recorder

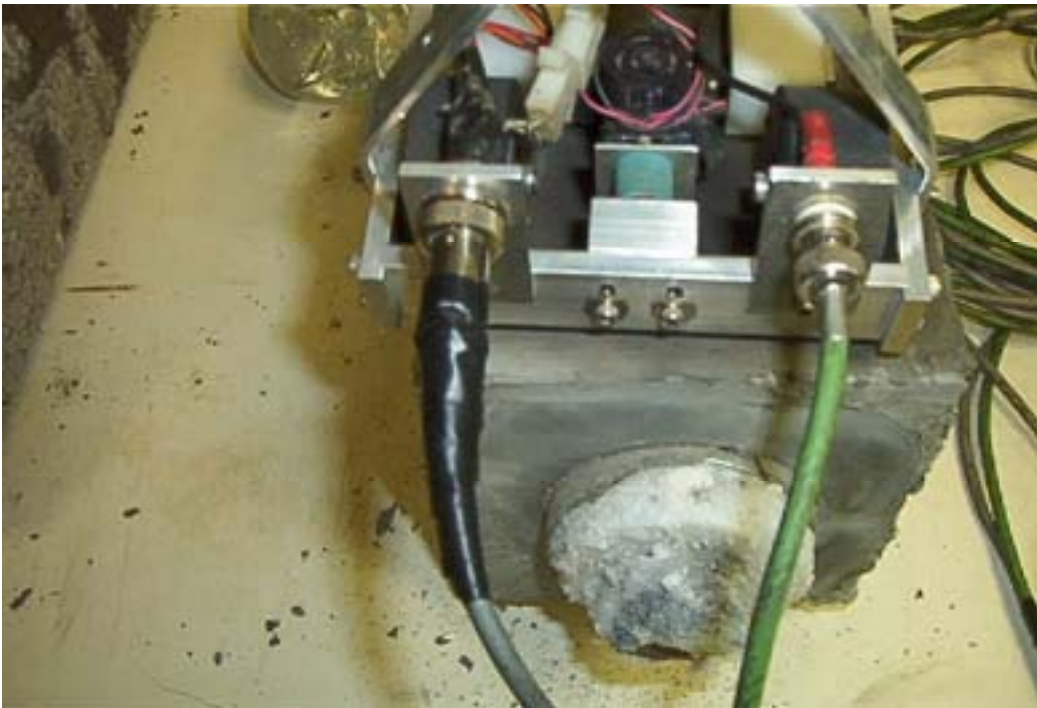
Figure 5.6 Close-up of Scanning IE Device Relative to Specimen Size

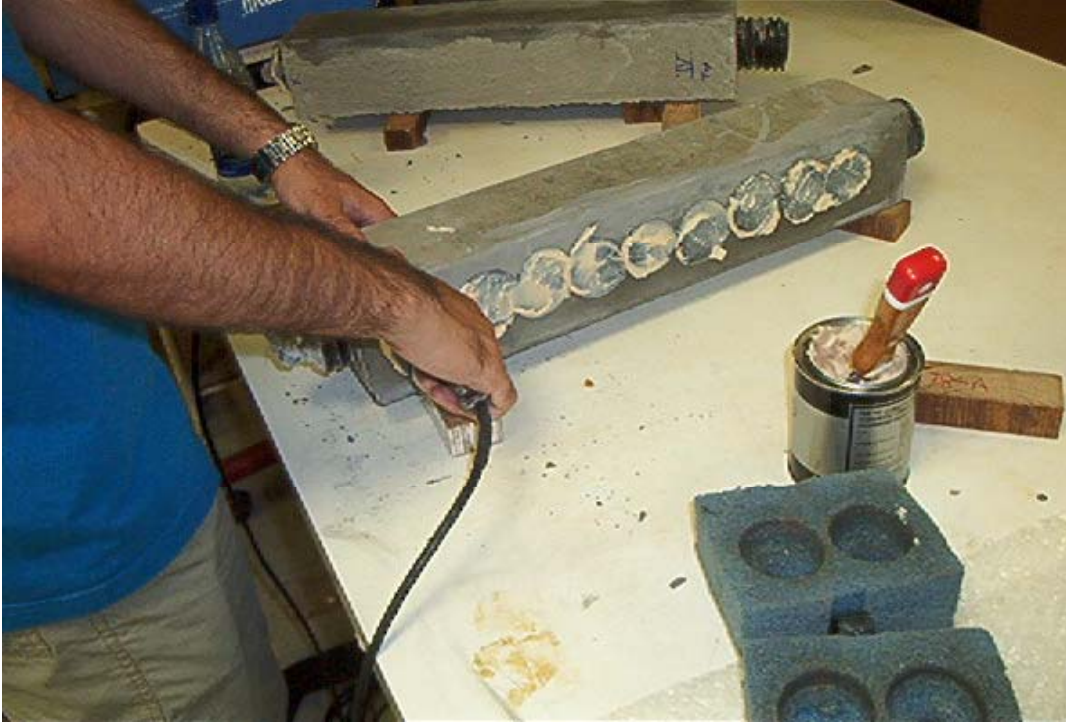
Figure 5.7 Static Ultrasonic Tomography (UT) Test

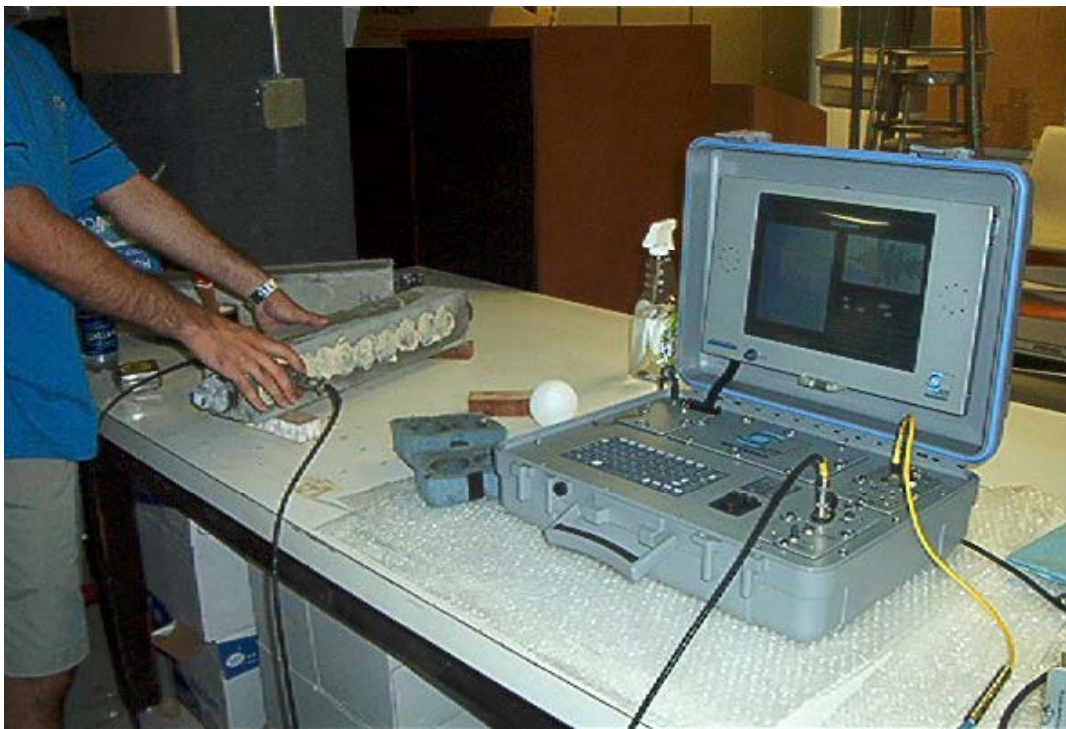
Figure 5.8 UT Test in Progress

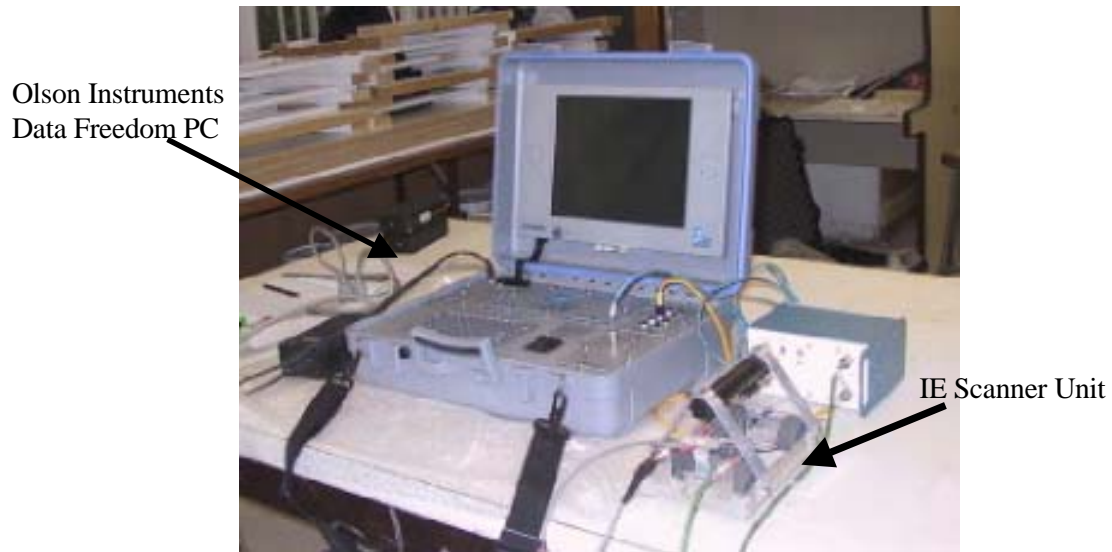
Figure 5.12 Freedom Data PC Acquisition System with IE Scanner

The Freedom Data PC acquisition system and an Impact Echo Scanning unit are shown in Fig. 5.12. The Impact Echo Scanning test is shown in Fig. 5.13.

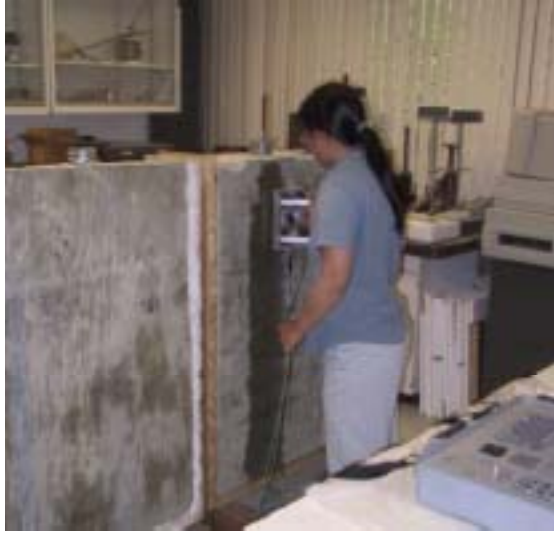
Figure 5.13 The Impact Echo Scanning test

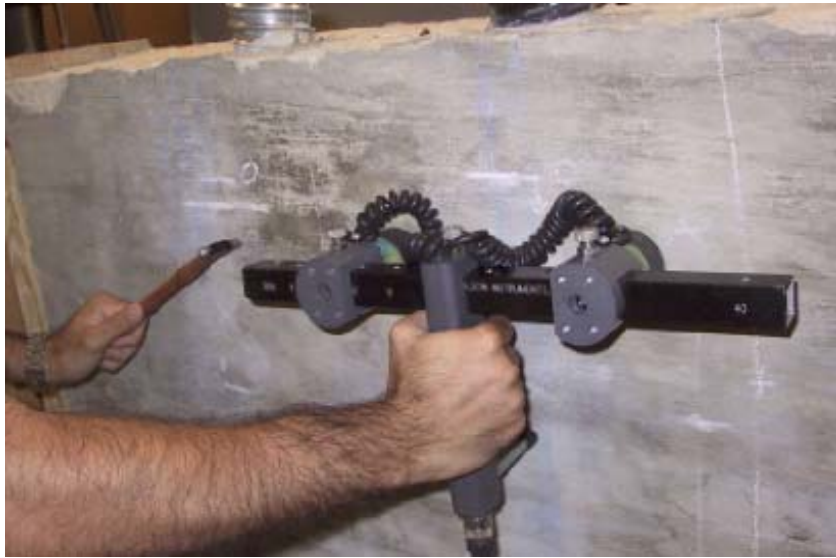
Figure 5.15 SASW Test on the Wall

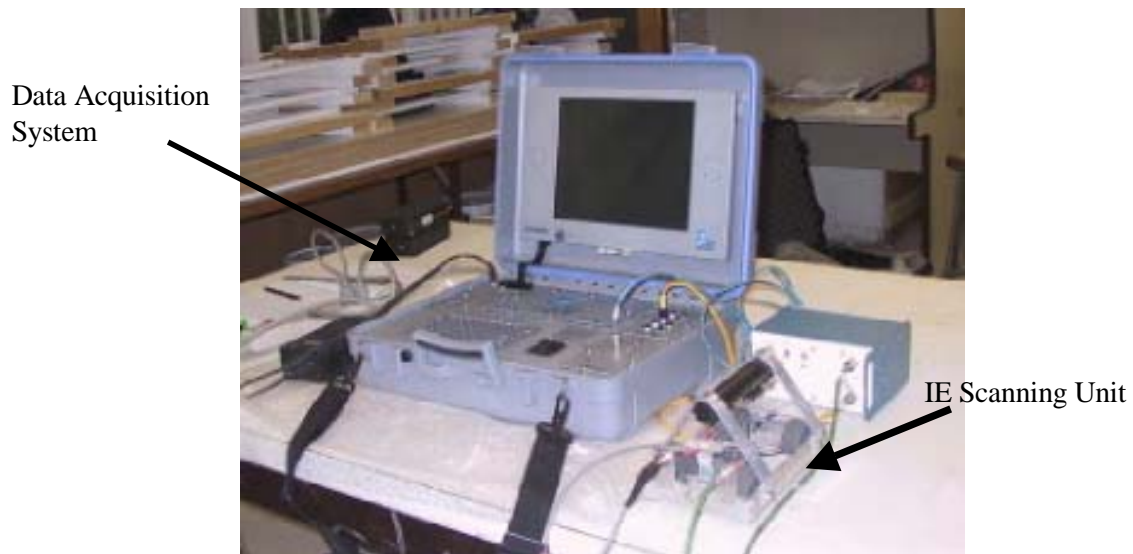
During this portion of the research, only Impact Echo (IE) Scanning was used to evaluate the internal grout condition of steel and plastic ducts. The IE Scanning system is shown in Fig. 5.33 below. The results from IE Scanning tests during the first phase of the research proved to be most promising among the technologies of IE Scanning, Ultrasonic Pulse Velocity (UPV) / Tomography and Spectral Analysis of Surface Waves (SASW).

Figure 5.33 Data Acquisition System with IE Scanning Device
